TESTING OF ASPHALT MIXTURES

NAME: CÉSAR VIAPIANA
SUPERVISOR: ING. PAVEL ŠPERKA
CZECH UNIVERSITY:
BRNO UNIVERSITY OF TECHNOLOGY

CZECH DEPARTMENT:
FACULTY OF CIVIL ENGINEERING, INSTITUTE OF ROAD
STRUCTURES

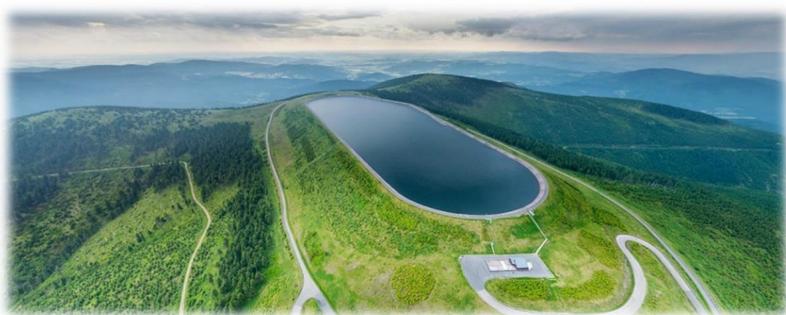
Figure 1. Dlouhé Stráně Lake. (source: seznam.cz)

The Dlouhé Stráně Lake is the reservoir of the Hydro Power Plant, in operation since 1996 (Figure 1). After 15 years, fissures problems started to appear. Therefore, a new asphalt mixture and methods that avoid failures for longer time is required.

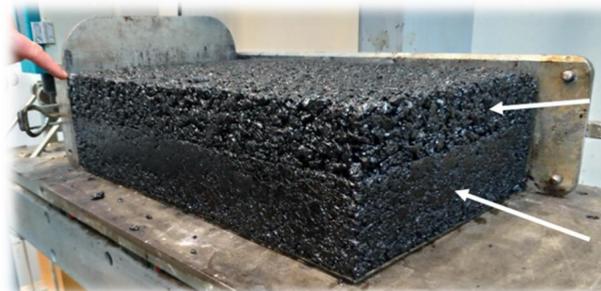
Figure 2. Lake pavement sample, with described layers (upside down)

BOTTOM LAYER
VABM 20% AIR VOIDS
(4% BITUMEN 70/100 +
0,4% BITHAFTIN)

TOP LAYER
VAB16 – 1% AIR VOIDS
(6,4% BITUMEN 70/100
+ 0,4% BITHAFTIN)

The design pavement is constituted of 2 layers described in Figure 2.

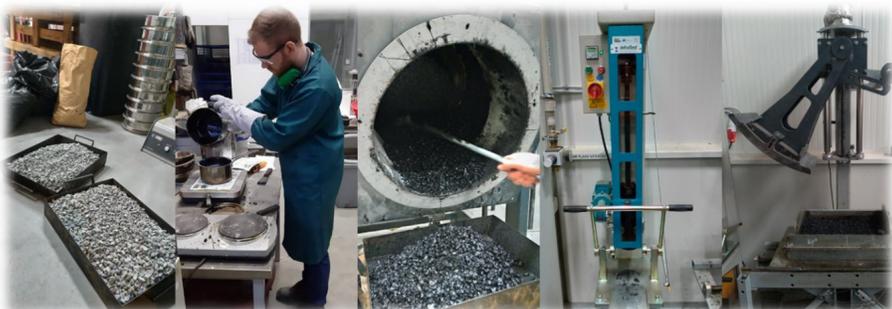
Figure 3. Preparing, mixing, and compacting the asphalt mixture

To produce the mixture, the aggregates, bitumen and *Bithaftin* additive were prepared and mixed as shown in Figure 3. For Marshall samples the Marshall Compactor was used, and for the pavement slab sample the Roller Compactor was used (Figure 3). Also to determinate mixture properties, the following tests were made: Bulk Density Determination, Maximum Density Determination in Pycnometer and Wheel Tracking Test.

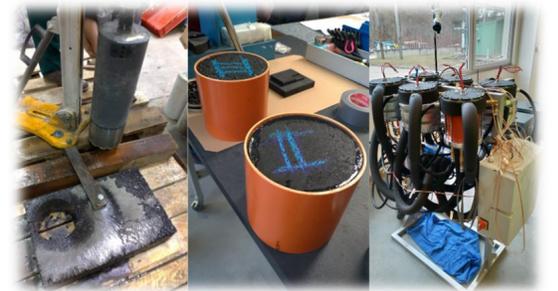
Figure 4. Drilled, prepared, and on test pavement samples

Also, from the pavement sample, cylindrical samples were drilled to be tested in a new prototype machine that simulates real conditions of the pavement in the lake (changeable pressure, and temperature switched heating and freezing)
